Mechanical failure of rock truck results in fatal runaway

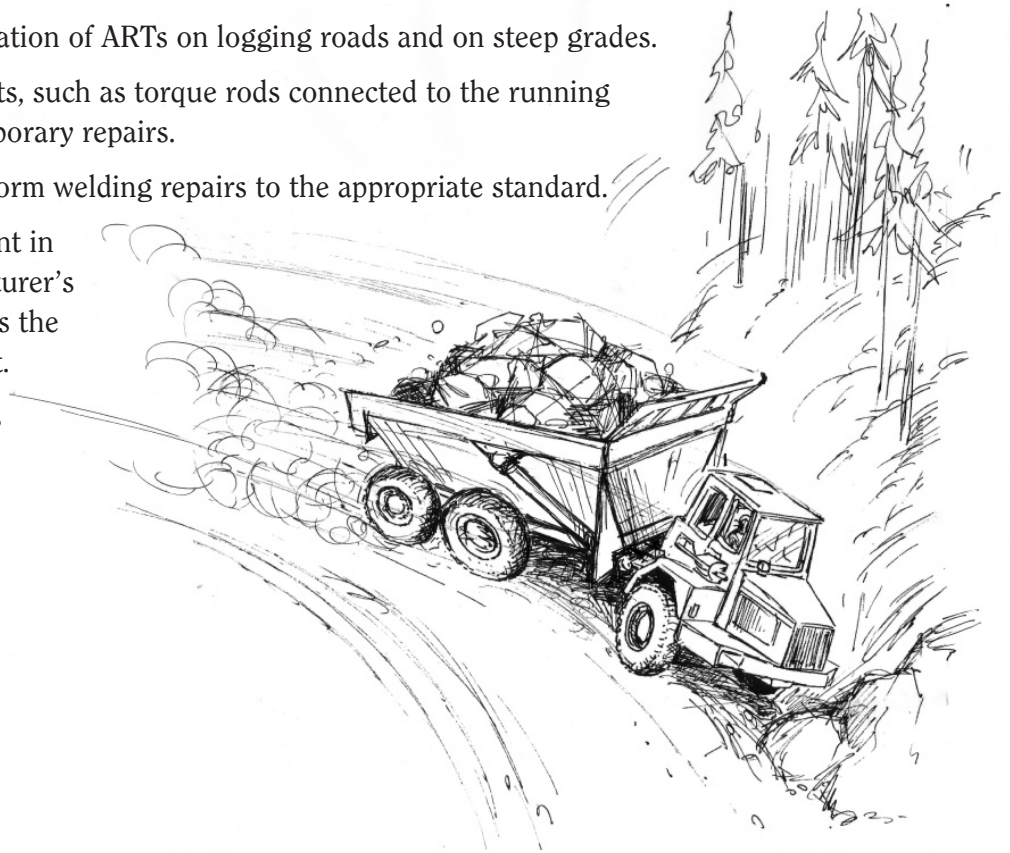
A young worker was operating an articulating rock truck (ART) that was hauling rock from a blast site. While the truck was travelling down a newly constructed steep logging road (23 percent), the brakes failed. To slow the truck down, the operator drove it into a ditch. The ART tipped onto its box and slid down the ditch line until the cab struck a large rock outcrop. The driver was ejected and was struck by a large rock that was thrown from the truck's load. He received fatal injuries.

The investigation found that a rear-axle torque rod had broken away from the housing at an improperly welded repair. Excessive movement of the box may have cut the rear brake line and air line. The front brakes and the partial use of the centre-axle brakes were not able to stop the truck as it gained speed on the steep hill.

- Train drivers on the safe operation of ARTs on logging roads and on steep grades.
- Replace defective integral parts, such as torque rods connected to the running gear, rather than making temporary repairs.
- Use a qualified person to perform welding repairs to the appropriate standard.
- Repair and maintain equipment in accordance with the manufacturer's instructions and any standards the equipment is required to meet.
- Ensure the required seat belts are provided and are worn by operators.
