SAFER Recognizes the Passing of Ralph McGinn

Update Cab Guard Design Project

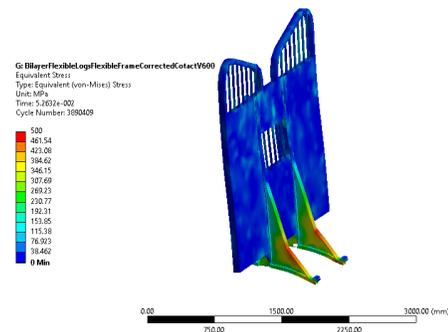
*Figure 1, Stress field for existing guard design when displaced 10 inches

The project team started work in February. They completed constructing the finite element model (FEM) of the existing cab guard design provided by a manufacturer of cab guards prior to being held up with the COVID 19 pandemic.

With a simple model of a log load, the results indicated the vertical members are not the weak point when considering deformations up to the point that the guard contacts the cab. The critical member is the foot, which is the beam that is bolted to the frame. This result was expected, which means the model is looking good.
