HAZARD ALERT

Block sorter's foot caught in moving conveyor

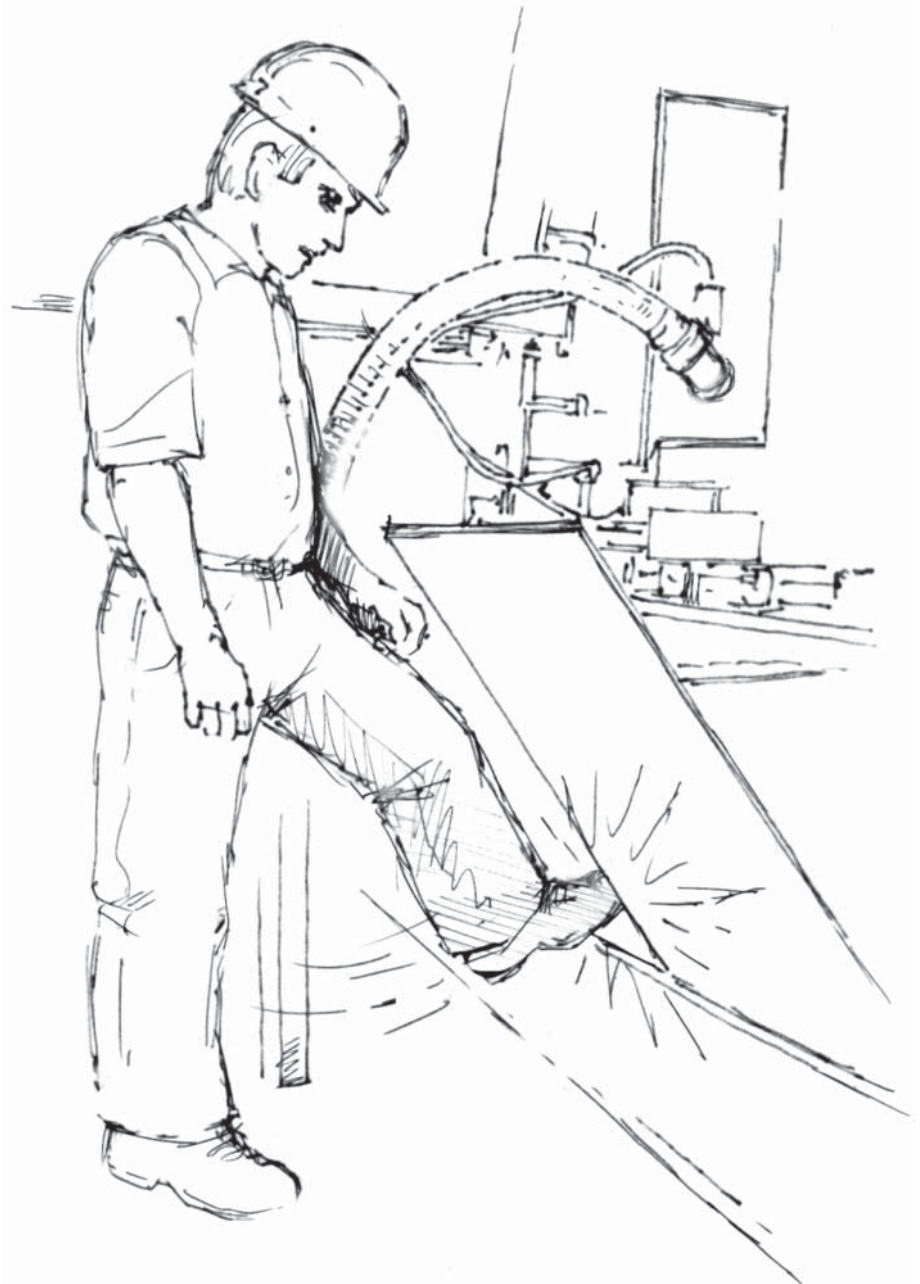
A block sorter attempted to clear a jam by kicking at a trimblock with his foot while a belt waste conveyor was still in motion. His foot was caught by the moving lug transfer chain and pulled into the idler roll shaft/bearing assembly, resulting in a compound fracture to his foot.

- Follow written safe work procedures for clearing jams.
- Use a picaroon or other effective tool to clear wood jams.
